TMS320C6202, TMS320C6202B
Digital Signal Processors
Silicon Errata

C6202 Silicon Revisions 1.0, 1.1, 1.2

C6202B Silicon Revisions 3.0, 3.1

SPRZ152H
November 2000
Revised February 2004

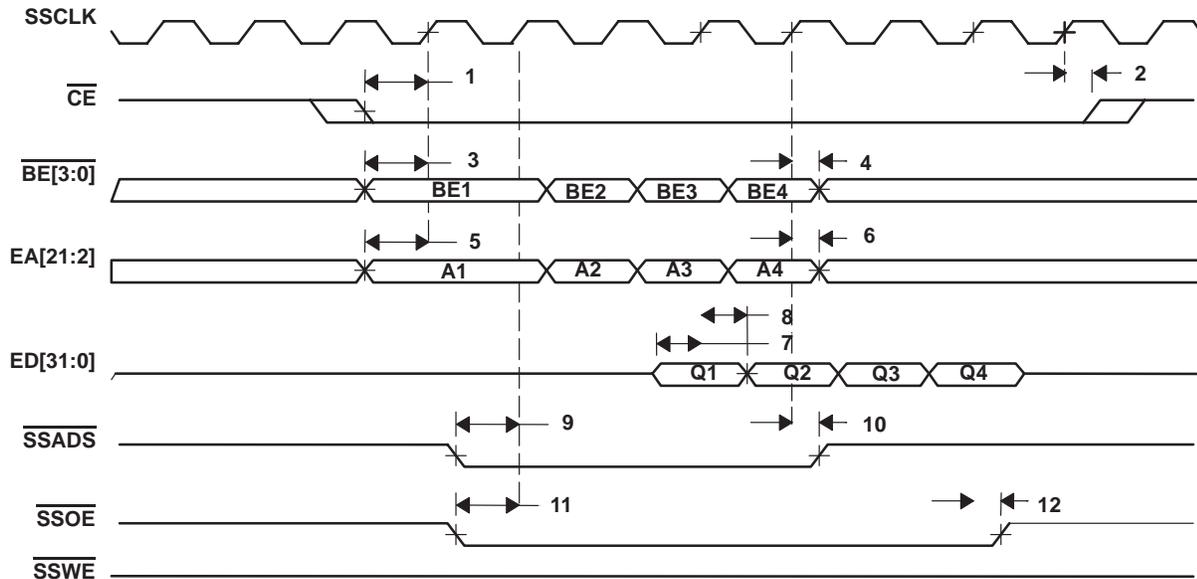
Figure 2. SBSRAM Read Timing

† The CEx output setup and hold times are specified to be accurate relative to the clock cycle to which they are referenced, since these timings are specified as minimums. However, the CE output setup and hold time may be greater than that shown in the data sheet in multiples of P ns. In other words, for output setup time, the CEx transition from high to low may happen P, 2P, ..., or nP ns before the time specified by the data sheet. Similarly, for output hold time, the CEx low-to-high transition may happen P, 2P, ..., or nP ns after the time specified by the data sheet. This is indicated by the period of uncertainty for specs 1 and 2 in Figure 2 and Figure 3.

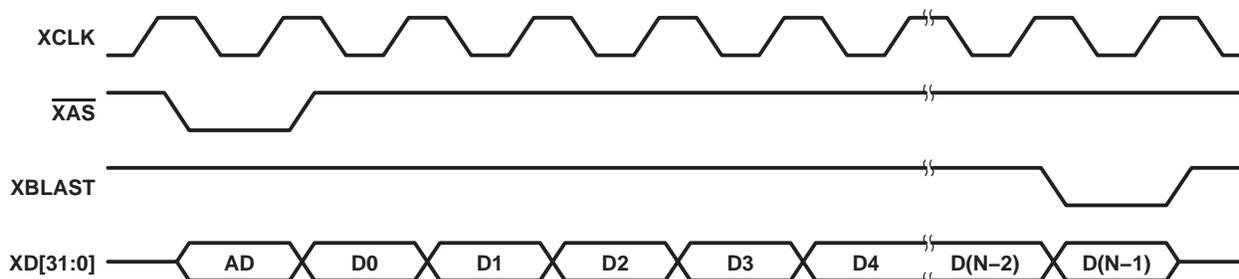
Figure 4. Correct Transfer of Address and Data via the Synchronous Host Port Mode of the Expansion Bus

While the expansion bus is operating in Synchronous Host Port Mode, certain expansion Bus output signals may be corrupted. The corruption occurs on output signals only and there are no known issues with any other XBUS modes (Asynchronous Host Mode, Asynchronous I/O Mode, or Synchronous FIFO Mode). In Synchronous Host Port Mode, some or all outputs of the XD signal lines move from the next word into the current word being transferred. This corruption not only affects the XD signal lines, but the output control signals as well (XAS, XBLAST, etc.). Figure 4 shows what a typical Synchronous Host transfer should look like. Figure 5 shows the address (AD), as well as data word 2 (D2) being corrupted by the next word. In this figure, the address is corrupted by D0 and D2 is written over by D3. Figure 6 is an example showing D0 being completely corrupted by D1 and D3 being partially corrupted by D4. The transfer should be 0x0001, 0xFF02, 0x0003, ..., 0xFF1F to Address 0x8000.

Workaround: The best method of reducing the number of failures resulting from this issue is to increase the voltage and decrease the CPU Clock speed. For Rev. 1.2, 1.8 V – 250 MHz devices should operate correctly at 1.9 V – 225 MHz. This issue will be fixed in the next major revision.

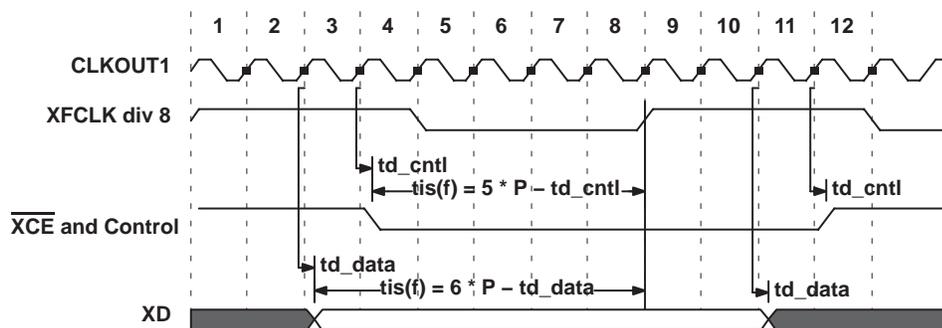
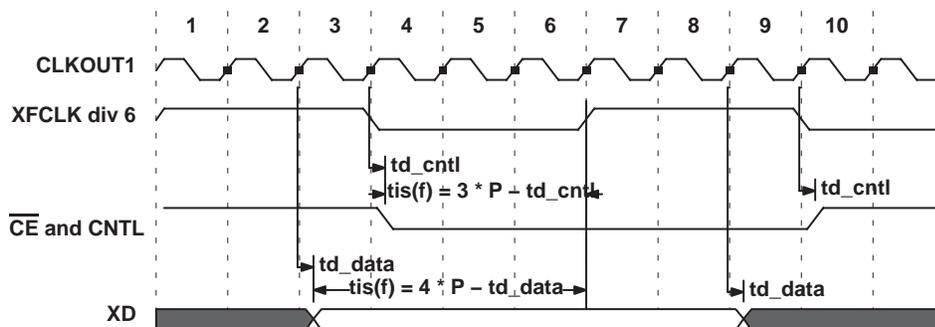
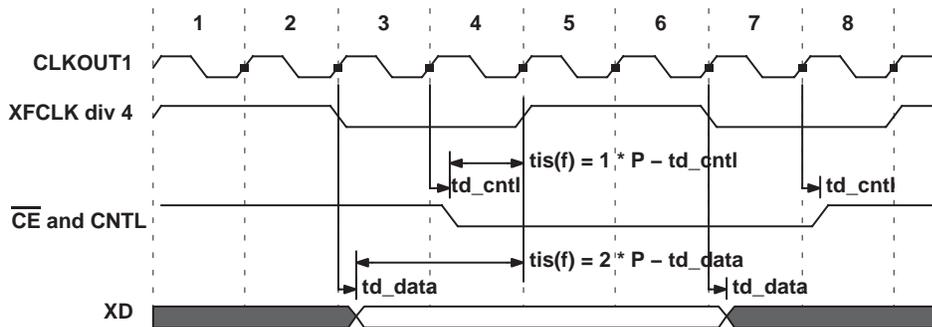
Details: In XBUS Synchronous FIFO mode, output data is skewed by two CPU clocks, while output control signals are skewed by three CPU clocks, regardless of the FIFO clock rate (XFRAT). As a result, there may not be enough data and control signal setup time to the next rising edge of XFCLK, where the FIFO is expected to latch the control/data. As shown in the diagrams below, the impact of the control and data skew is less significant for the slower clock speeds.

For example, at XFCLK divided by 8, the control signal skew of three cycles leaves five CPU cycles of setup time before the next rising edge of XFCLK. For XFCLK divided by 6, the three CPU cycles of skew on the control bus leaves three CPU cycles of setup time to the next rising XFCLK edge. For XFCLK divided by 4, the three CPU cycles of skew on the control bus leave one CPU cycle of setup to the next rising XFCLK edge. Although not shown, the situation is the same for XFCLK divided by 2.

On reads, the FIFO control signal outputs are skewed exactly as in the write case. However, the XBUS latches data correctly on the rising edge of XFCLK for all XFCLK divide ratios. (Internal reference number C630489)

Workaround: Select a slower FIFO clock rate (XFRAT) such that the FIFO setup time is met.
