TMS320R2811 and TMS320R2812 Digital Signal Processors

Silicon Errata

Literature Number: SPRZ226E
June 2004–Revised September 2016

TMS320R281x Silicon Errata

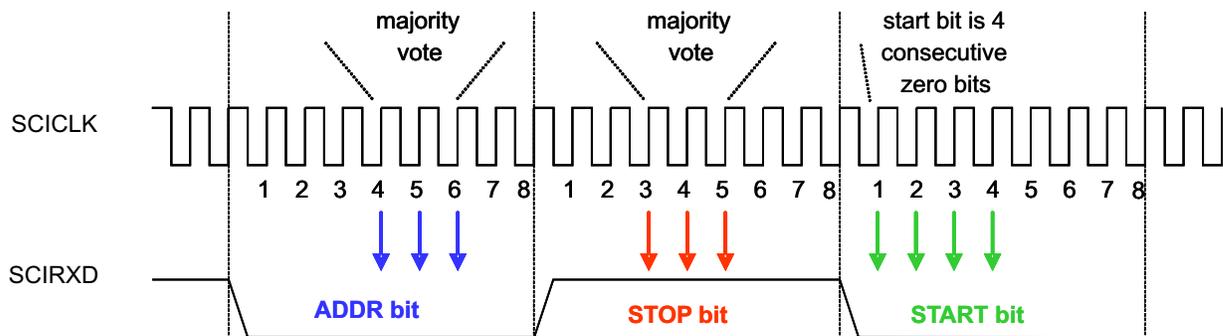
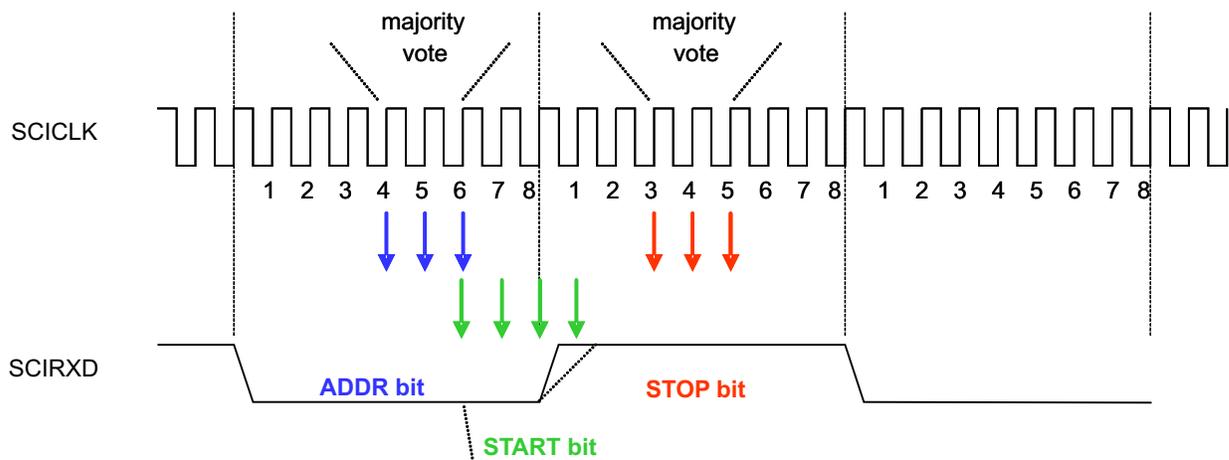
Figure 3. Difference Between Expected and Erroneous Operation of START Bit

Details The SCI does not look for the STOP bit after the ADDR bit. Instead, the SCI starts looking for the start bit beginning on sub-sample 6 of the ADDR bit. Slow rise time from the ADDR bit to the STOP bit can cause a false START bit to occur since the 4th sub-sample for the start bit may be sensed low.

Workaround(s) Program the baud rate of the SCI to be slightly slower than the actual. This will cause the 4th sub-sample of the false START bit to be delayed in time, and therefore occur more towards the middle of the STOP bit (away from the signal transition region). The amount of baud-slowng needed depends on the rise time of the signal in the system. Alternatively, the IDLE mode of the SCI module may be used, if applicable.
