TMS320C6202, TMS320C6202B
Digital Signal Processors
Silicon Errata

C6202 Silicon Revisions 1.0, 1.1, 1.2

C6202B Silicon Revisions 3.0, 3.1

SPRZ152H
November 2000
Revised February 2004

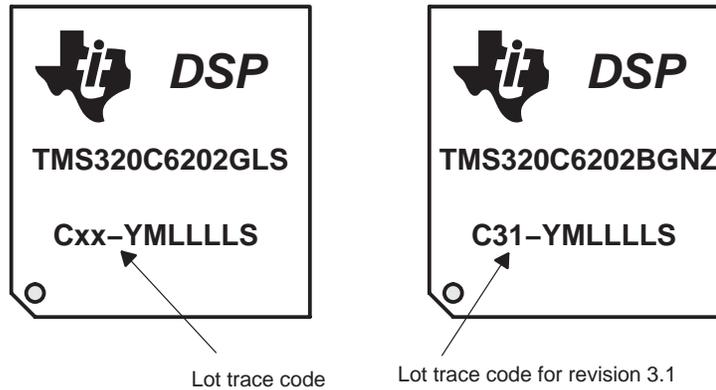
Figure 1. Example, Lot Trace Code for TMS320C6202 and TMS320C6202B

The device revision can be determined by the lot trace code marked on the top of the package. The location of the lot trace code for the GLS (C6202) and the GNZ (C6202B) packages is shown in Figure 1.
